**CASE STUDY**

**CLEARWELL ADDRESSES SEVERE SCALING IN A 17-WELL PAD WITH MULTIPLE EARTHING POINTS.**

**LOCATION:** Alberta, Canada

**APPLICATION:** Gas Lift

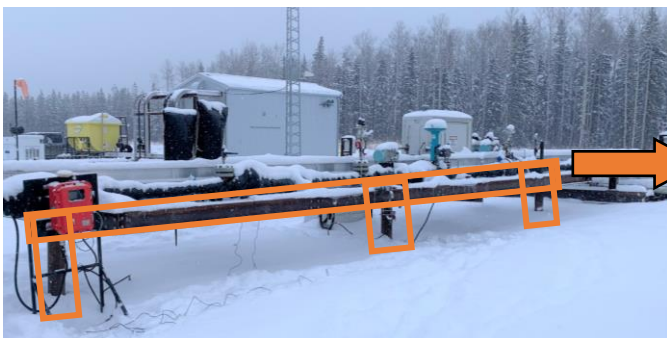
Site testing by ClearWELL concluded that the facility had multiple ground paths and loops which would affect the normal propagation of the electromagnetic field. Figure 1 below shows a representation of the piles and resulting ground loops.

The facility had been developed with a complex architecture whereby each well was in very close proximity to the next and connected to each other through the surface system. The additional five wells were installed with metal support piles and an underground meshed system.
