CASE STUDY

CLEARWELL PROTECTS ROD PUMP OIL WELL AND DOWNHOLE EQUIPMENT FROM CALCITE SCALING.

LOCATION: Tunisia

APPLICATION: Rod Pump Oil Well

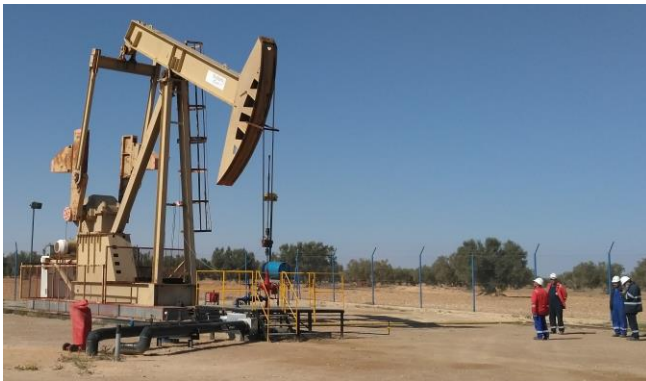
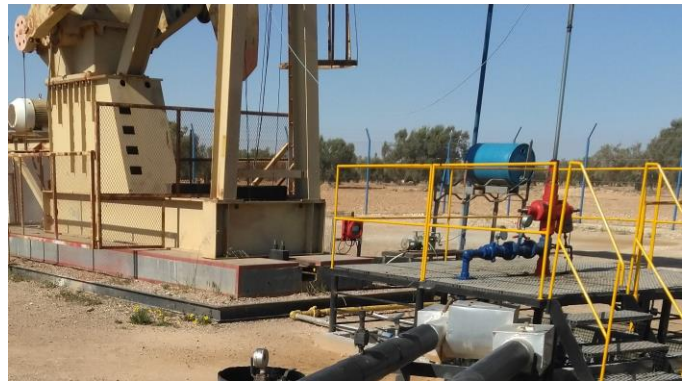
BEFORE CLEARWELL™

An oil and gas operator in Tunisia was experiencing a severe build-up of calcite scale in a rod pump oil well. The scale had been plugging the well's sand screen and affecting the pump, causing the downhole equipment to fail on average every three months.

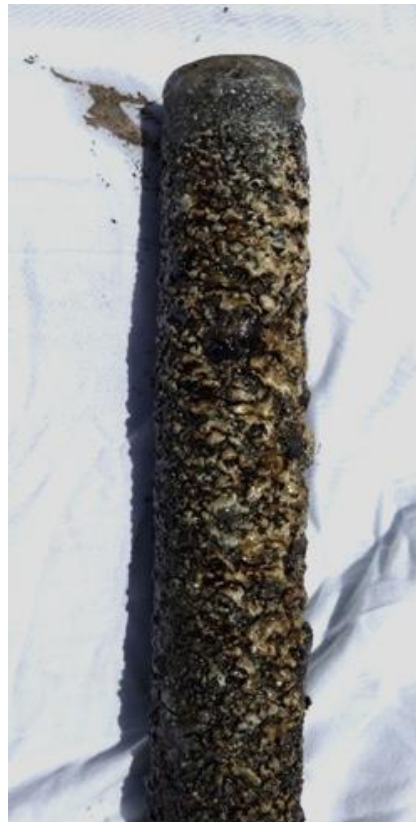
BEFORE CLEARWELL™

The photos opposite show the calcite scale deposition on a sand screen after 5 months of operation in this well, **before** ClearWELL™ was installed (left) and a sand screen from the same well, 5 months **after** ClearWELL™ was installed (right).

After nearly six months of trouble-free production and excellent pump performance, the operator pulled the sand screen to inspect it for signs of scale. The photos overleaf demonstrate the outstanding performance of the ClearWELL™ technology, showing a sand screen that had been in the well for five months prior to using ClearWELL™ and one which had been in the well for the same period of time but operating under the protection of our technology.
